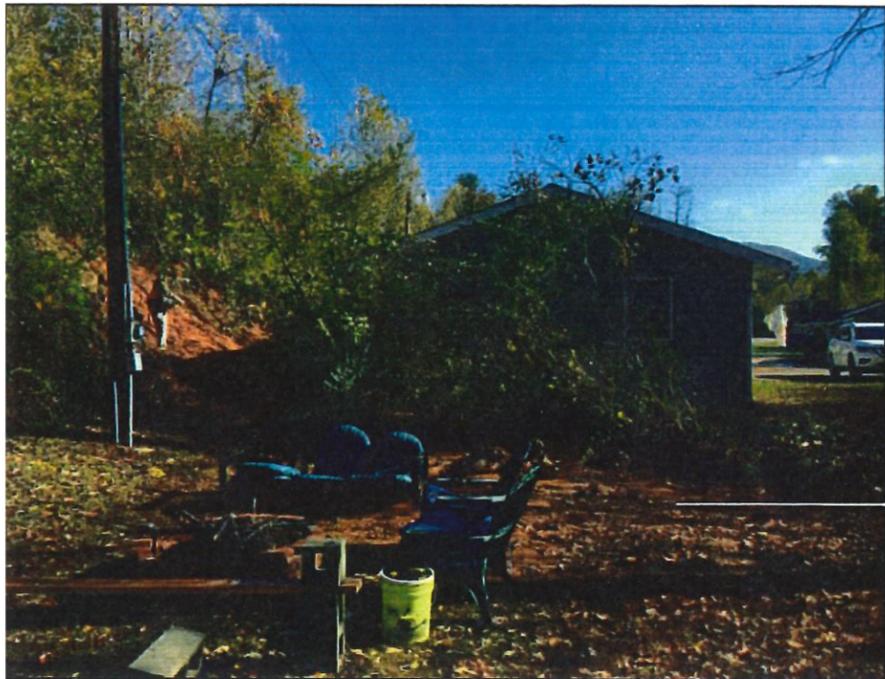
Source area of 2019\_10\_31 slide upslope (left) of damaged dwelling at 68 Cavalier Drive. Portion of slide mass with displaced vegetation visible in photo middle ground. 2019\_11\_01 NCGS photo.

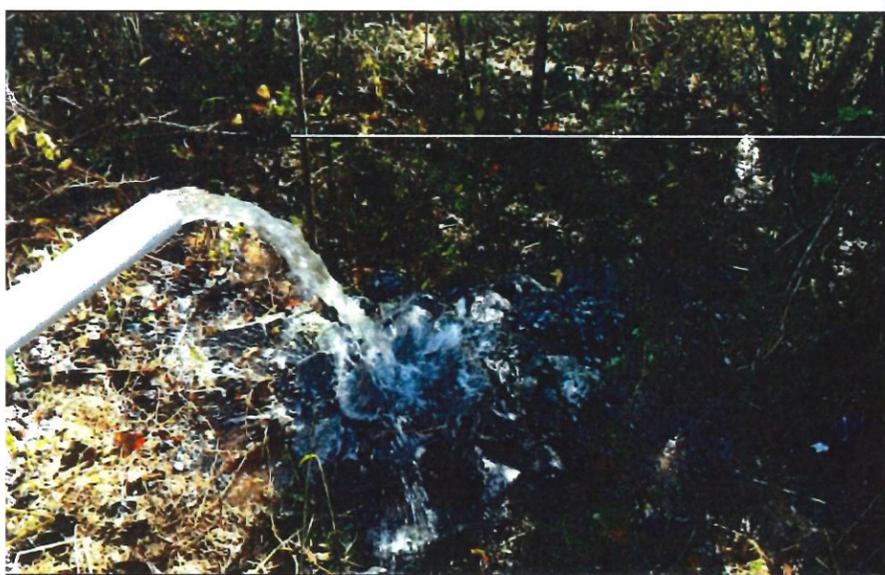
Skimmer discharge pipe above slide area. Overland water flow below outlet infiltrates into the slope immediately above the slide area. 2019\_11\_01 NCGS photo.

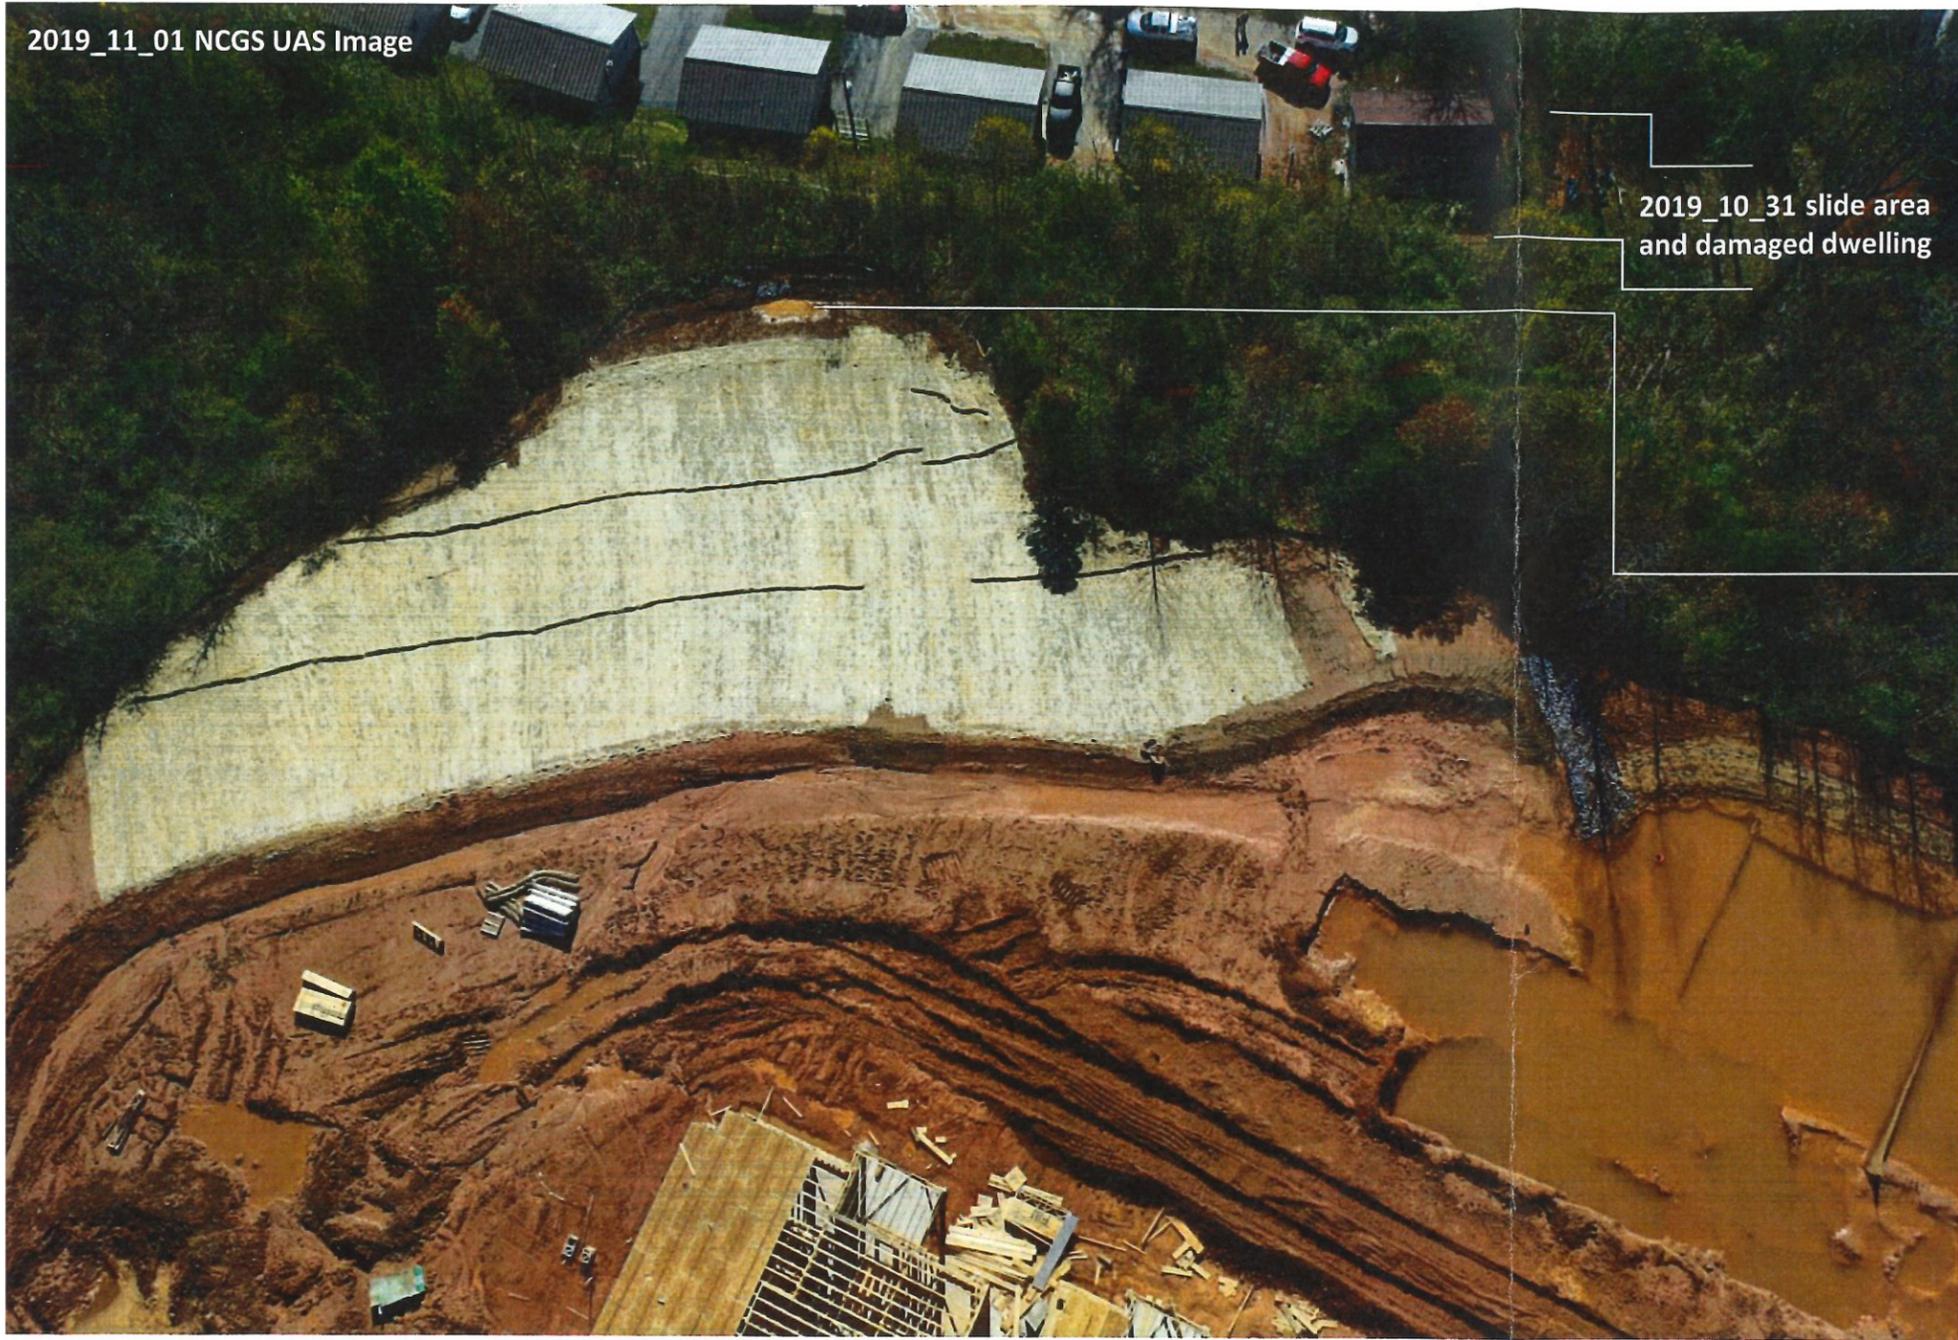
2019\_10\_31 slide area and damaged dwelling
